**Pedestal Crane  
(Articulating Telescopic Boom)  
TIK-5-0377**

**Customer** : **PERTAMINA HULU MAHAKAM**  
**Location** : **NPU - LOADING JETTY**  
**Inspection Date** : **2022/07/05**  
**Inspector (s)** : **- Yonas Febrian**  
 : **- Nico Achmad Z.**

## REPORT OF TEST & THOROUGH EXAMINATION OF A CRANE

**LIFTING EQUIPMENT AND BURNER BOOM MAINTENANCE (JOB - 4600005733)**

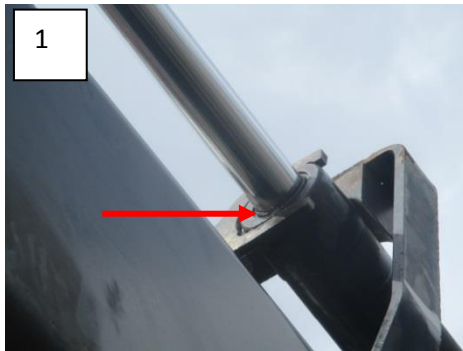
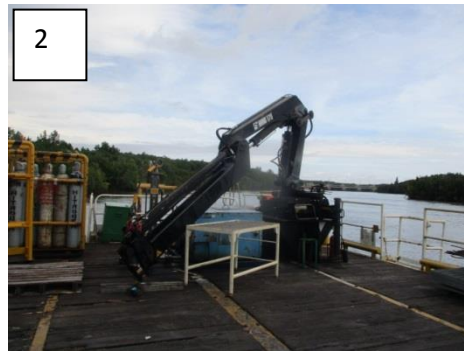
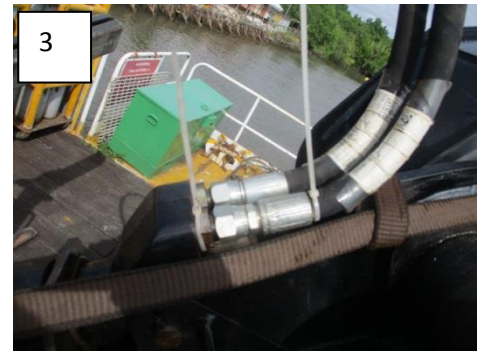
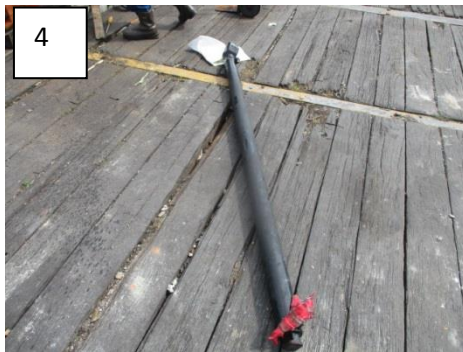
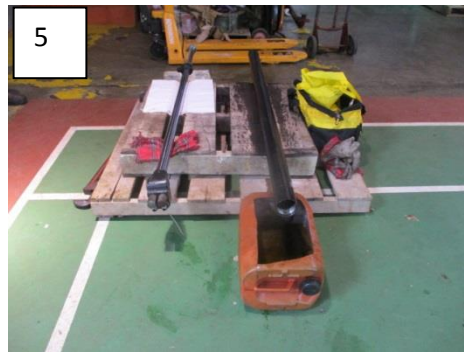
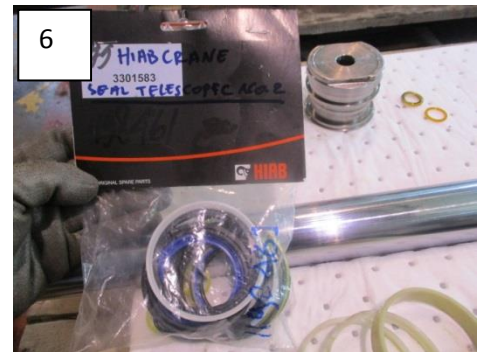
**Subject** : Intervention Oil leaks at boom cylinder telescope #1 and Oil leak at Swing gearbox

1. Pre-check condition of Cylinder telescope #1, oil leak/oil already come out from lip seal
2. Reposition boom telescope on position accessible intervention cylinder telescope #1
3. Marking hydraulic hose cylinder telescope and disconnected hyd.hose and tubing connectors
4. Removed cylinder telescope #1, with remove upper pin and remove lock base mounting cylinder at bottom position
5. Transfer telescope cylinder to the workshop and dismantle for cylinder
6. Identification part number for seal Cylinder boom Telescope #1 : **3301583**

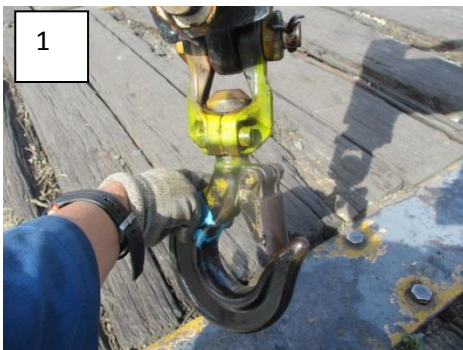
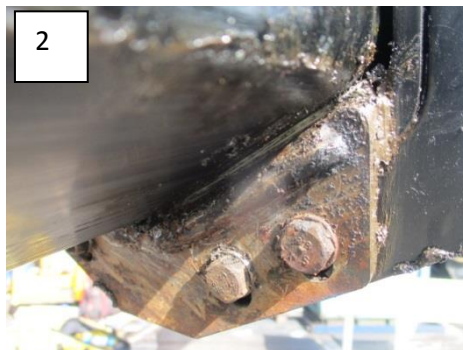
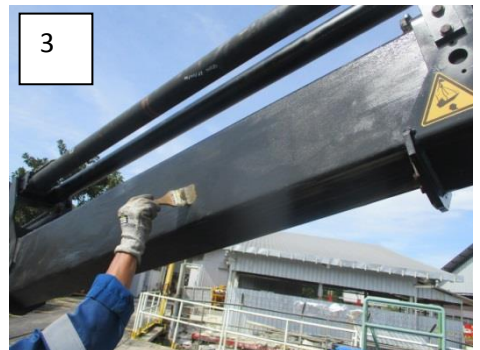
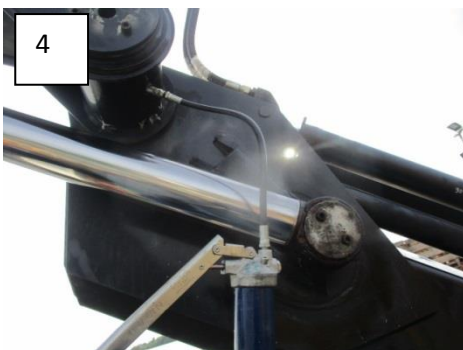
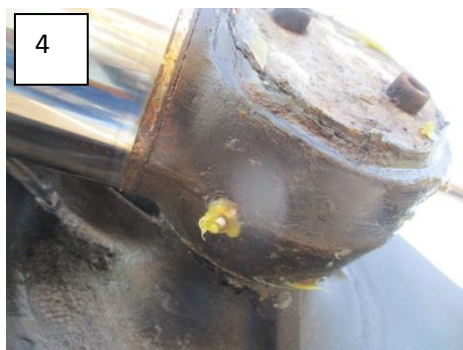
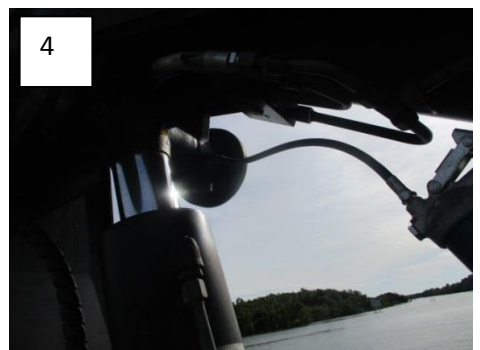
1. Follow up finding to adjustment spring on safety latch hook, lubricated hook pin
2. Check slide pad telescope, found over all is going to worn out
3. Lubricated telescope boom
4. Follow up finding to replaced nipple grease on crane, replaced for 3 pieces (done)  
Lubricated all nipple grease point at all cylinder boom or knuckle boom

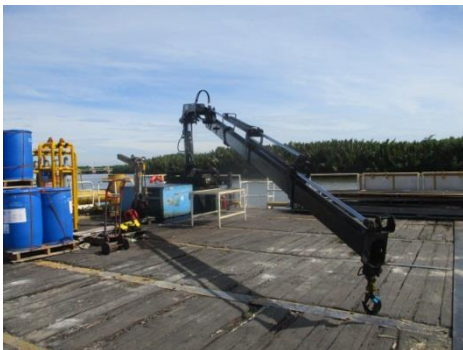
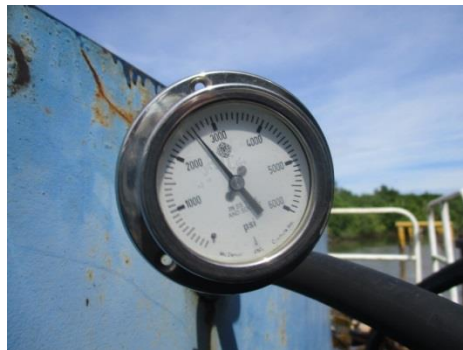
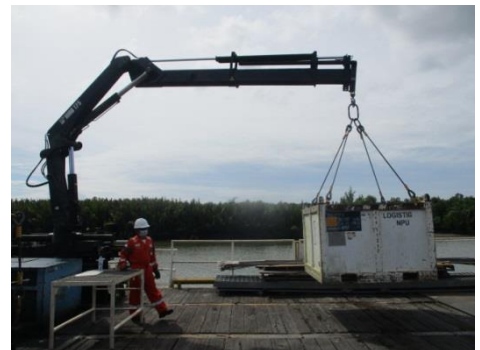
❖ **Perform Function test after re-seal cylinder boom**

**Perform general function test without load and reading working pressure:**

| ❖ Telescope <b>out</b> : 2800 Psi, | Telescope <b>in</b> : 2600 Psi |
| ❖ Outer boom <b>out</b> : 2700 Psi, | Outer boom <b>in</b> : 2100 Psi |
| ❖ Inner boom <b>out</b> : 3500 Psi, | Inner boom <b>in</b> : 3600 Psi |
| ❖ Slew <b>right</b> : 3300 Psi, | Slew <b>left</b> : 3300 Psi |

Monitoring condition of hydraulic cylinder telescope #1 during crane operation, found good  
Function test with load main basket (name plate weight tare 740 Kg), found good performance

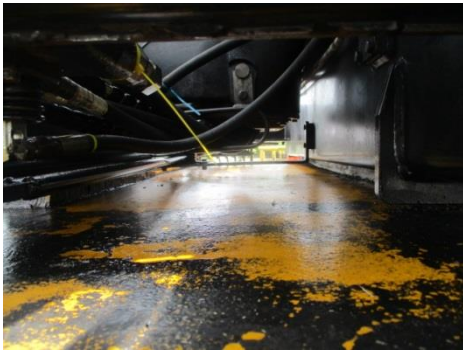
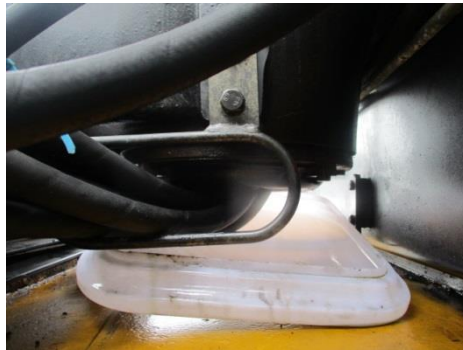
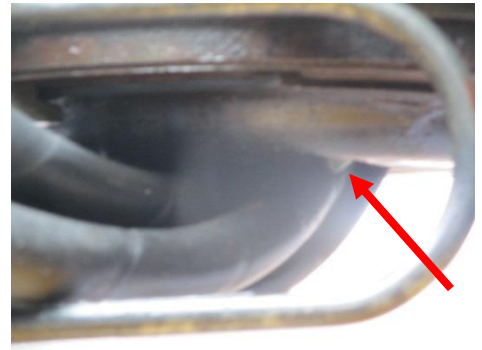
❖ FINDING REPORT

- Found see page oil at swing gearbox area
- Identify see page oil is gear oil/SAE 85-90
- Temporary action with put on small basket under swing gearbox
- Recommended to replace, **o ring P/N: 9921567**
- Recommended to replace, **seal P/N: 9818260**

**Note: to replacement of seal gearbox, have to remove crane unit from lower base for accessible works**
