**PEDESTAL CRANE
BOX – LATTICE BOOM
TIK 2-2211**

Customer : PERTAMINA HULU MAHAKAM
Location : SWP - E – PECIKO
Inspection Date : 2022/01/06
Inspector(s) : - Wahyudhi
: - USMAN K

REPORT OF TEST & THOROUGH EXAMINATION OF A CRANE

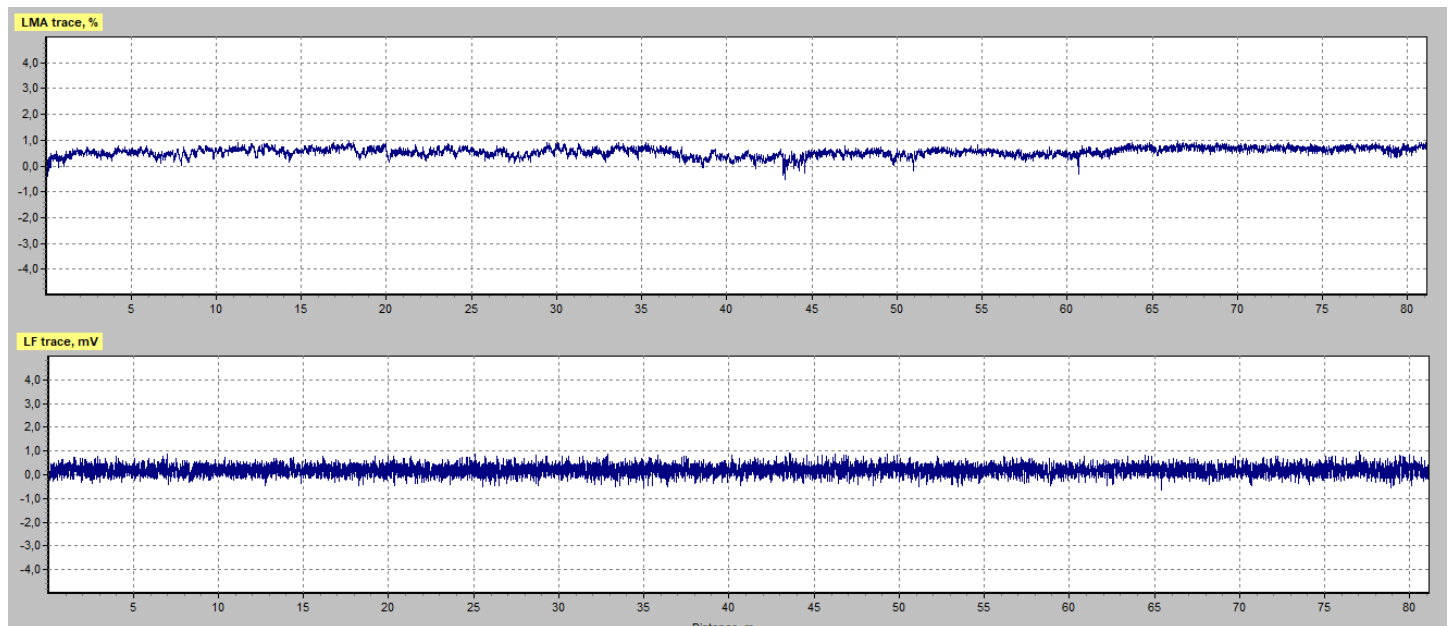
MAIN HOIST

No defect found at the time of inspection, as shown by chart below:

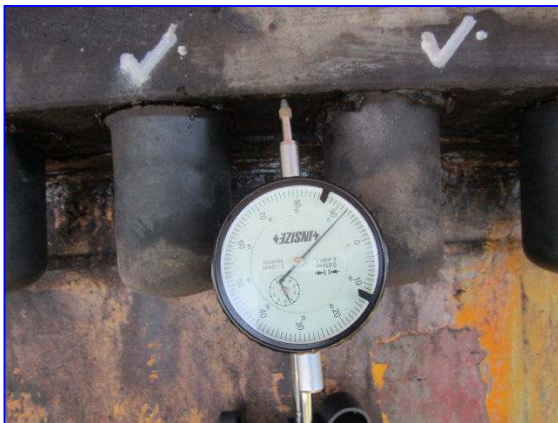
0° = 0,92

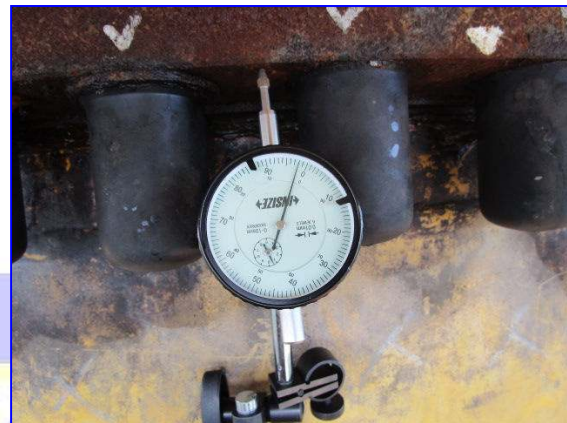
Based on slew bearing measurement with dial indicator max. clearance indicated 0.98 mm, and the maximum permissible bearing measurement provides by crane manufacture or bearing manufacture.

90° = 0,98

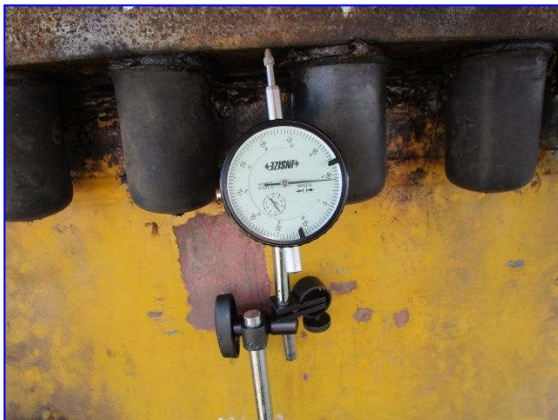
180° = 0,91

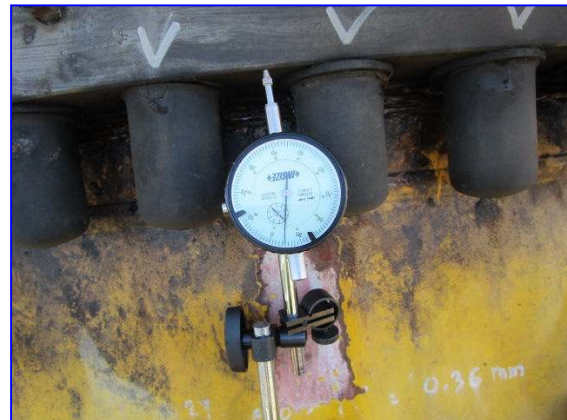
270° = 0,95

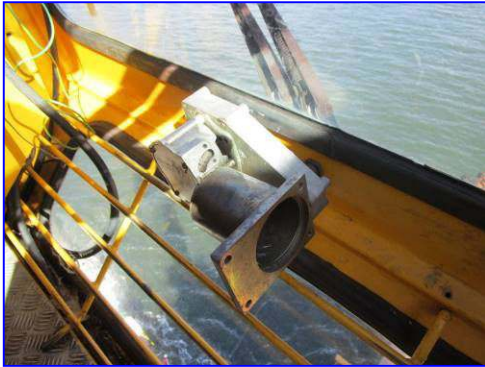
Cabin Glass Wiper not function, Wiper motor was broken shall be repaired

1. *Cabin Glass Wiper not Function, Wiper Motor was Broken Shall be Repaired*
2. *Operator Leather Seat was Broken, Should be Repaired*
3. *Boom Angle Degree Display Malfunction, Should be Repaired*
4. *Luff Control Valve for Boom Cylinder Found Leaking, Should be Repaired*
5. *Communication Operational is not Available, to be Provided*

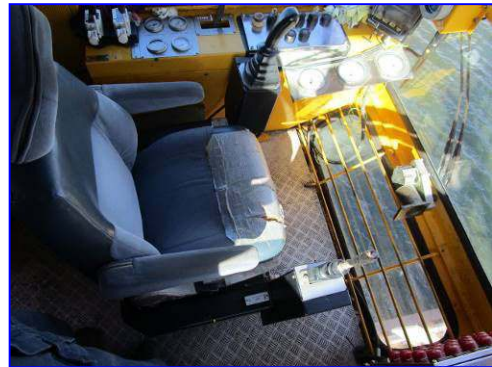
Operator leather seat was broken, should be repaired

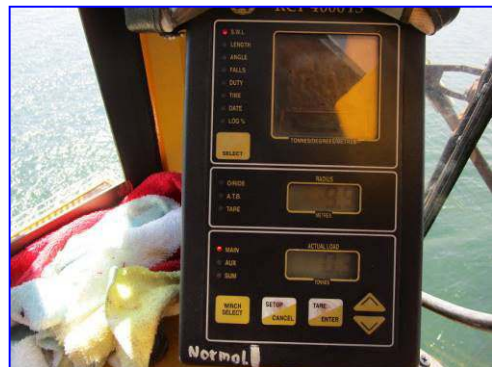
Load Indicator RCI – 4000 /S
ROBWAY S/N 0281
Boom Angle Degree Display Malfunction

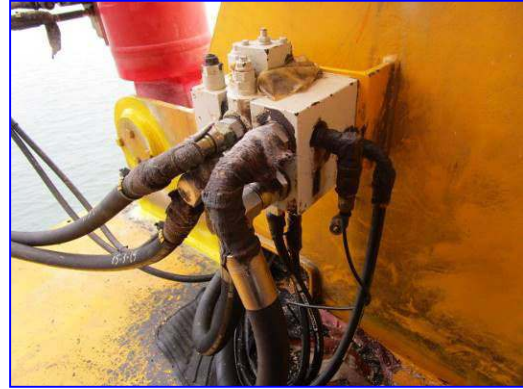
Luff Control Valve for Boom Cylinder Found Leaking
