**PEDESTAL CRANE
BOX – LATTICE BOOM
TIK 2-2211**

Customer : PERTAMINA HULU MAHAKAM
Location : SWP - E – PECIKO
Inspection Date : 2022/01/06
Inspector(s) : - Wahyudhi
: - USMAN K

REPORT OF TEST & THOROUGH EXAMINATION OF A CRANE

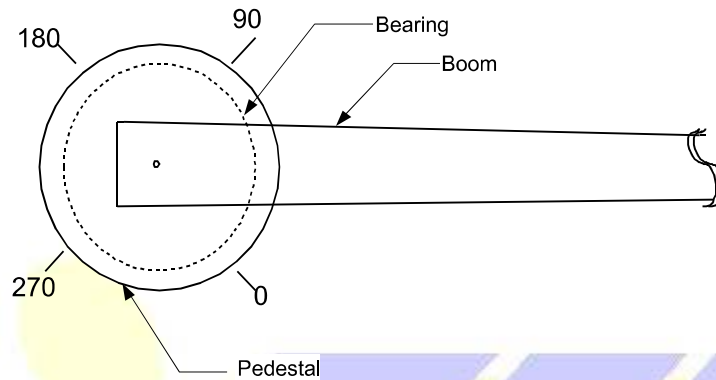
SKETCH POSITION DIAL INDICATOR ON BEARING**

Based on slew bearing measurement with dial indicator max. clearance indicated 0.98 mm, and the maximum permissible bearing measurement provides by crane manufacture or bearing manufacture.

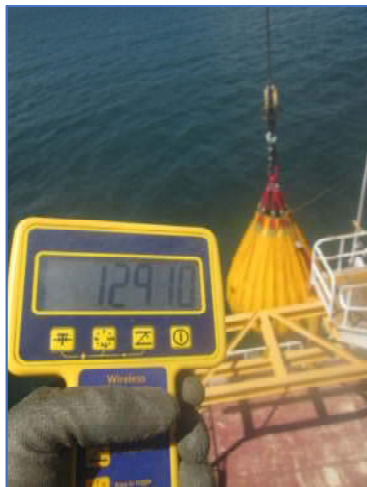
Radius : 10 m
Angle : 69°
Boom Length : 27.6 m (Main Hoist)

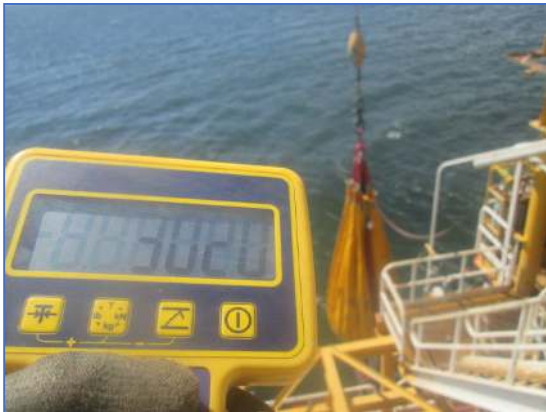
Radius :10 m
Angle :69°
Boom Length : 27.6 m (Auxiliary Hoist)

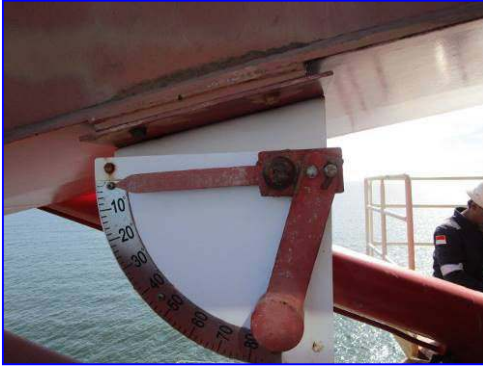
Boom Angle Indicator

- Finding:
- 1. Cabin Glass Wiper not function, Wiper motor Broken, shall be Repair*
 - 2. Operator Leather seat was Broken, should be Repair*
 - 3. Boom Angle Degree Display malfunction, should be Repair*
 - 4. LUFF Control Valve for Boom Cylinder found Leaking, should be Repair*
 - 5. Communication Operational not Available, to be Provided.*
